Laser array spots thermography for detection of cracks in curved structures

Jinxing Qiu¹, Cuixiang Pei^{1, 2*}, Yang Yang¹, Haochen Liu³ and Zhenmao Chen^{1*}

Abstract. The laser array spot thermography (LAST) is a fully non-contact and non-destructive method for the inspection of surface cracks with high efficiency. In this study, the detection capability of this method for the inspection of surface cracks in structures with curved surfaces is experimentally studied. The influence of the inspection angle on the crack imaging results is also investigated. The experiment results show that cracks in surface of the pipes with different dimeters can be detected and imaged by LAST.

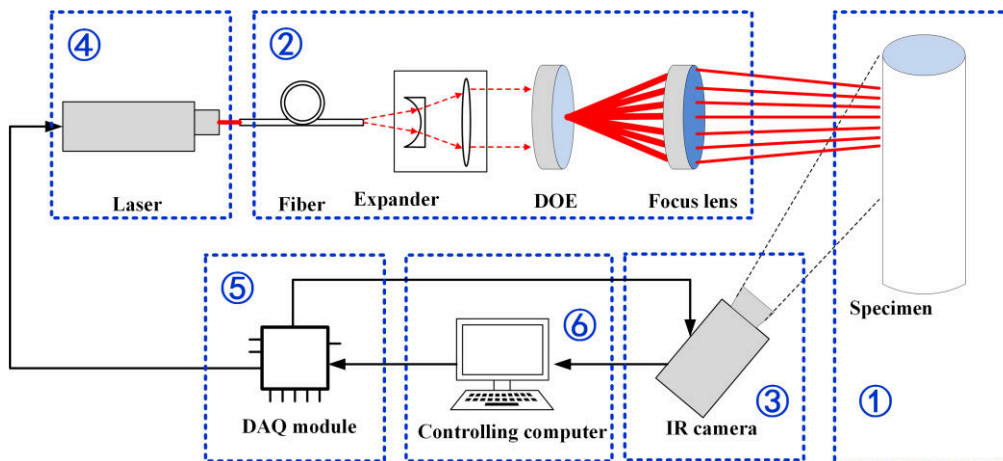
Fig. 1. Picture of laser array spot thermography experiment system. The system contains (1) specimen and holder; (2) optical components, comprise of a laser expander, a DOE and a PCL; (3) IR camera; (4) continuous-wave laser; (5) DAQ model; (6) controlling computer.

The established LAST system for inspection of surface cracks is shown in Fig. 1. The experimental setup includes a continuous heat source, an infrared camera, a data acquisition (DAQ) module and a set of optical components. The heat source is a continuous-wave (CW) laser with 1064 nm wavelength and maximum power of 100W. The thermal images were acquired by a mid-wave infrared thermal camera with a resolution of 512×640 pixel and frame frequency of 60Hz. The laser output power and duration are controlled by a DAQ module of ARM, which also output camera trigger signal to synchronize the capture of infrared images and laser turn on. The optical components contain a diffractive optical element (DOE) and a plano-convex lens (PCL) laser to split the single point laser beam into a 9×9 laser array.

The working principle of the system is as follows. First, the controlling computer sends out a trigger signal to the DAQ module to activate the inspection procedure. Then, a periodic voltage signal is generated by DAQ module and transmit to laser driver. This voltage signal is amplified and then drive the laser to generate laser beam. At the same time, another periodic voltage signal generated by the DAQ module is also transmitted to the IR camera to synchronize data acquisition with the laser excitation. Once generated, the initial single laser beam is split into a laser beam array by the optical components. Finally, the laser spots array is exerted onto the target surface of interest, generating thermal waves and finally reveal the surface cracks. The technical specifications of equipment and details of the optical components designing have been carefully discussed in [7].

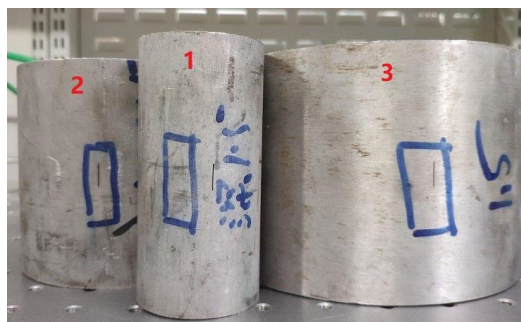
Fig. 2. Picture of SUS pipes specimens with diameters of 50mm, 100mm, 150mm.

To examine the performance of the LAST technique, experimental evaluation is performed. As shown in Fig. 2, the specimen used in experiments are three pipes made of SUS 304. Small notches were respectively

introduced in the outer surface of three pipes using a wire-cut electric discharge machining (EDM) to simulate the surface cracks. The specifications of specimens and cracks are shown in Table 1.

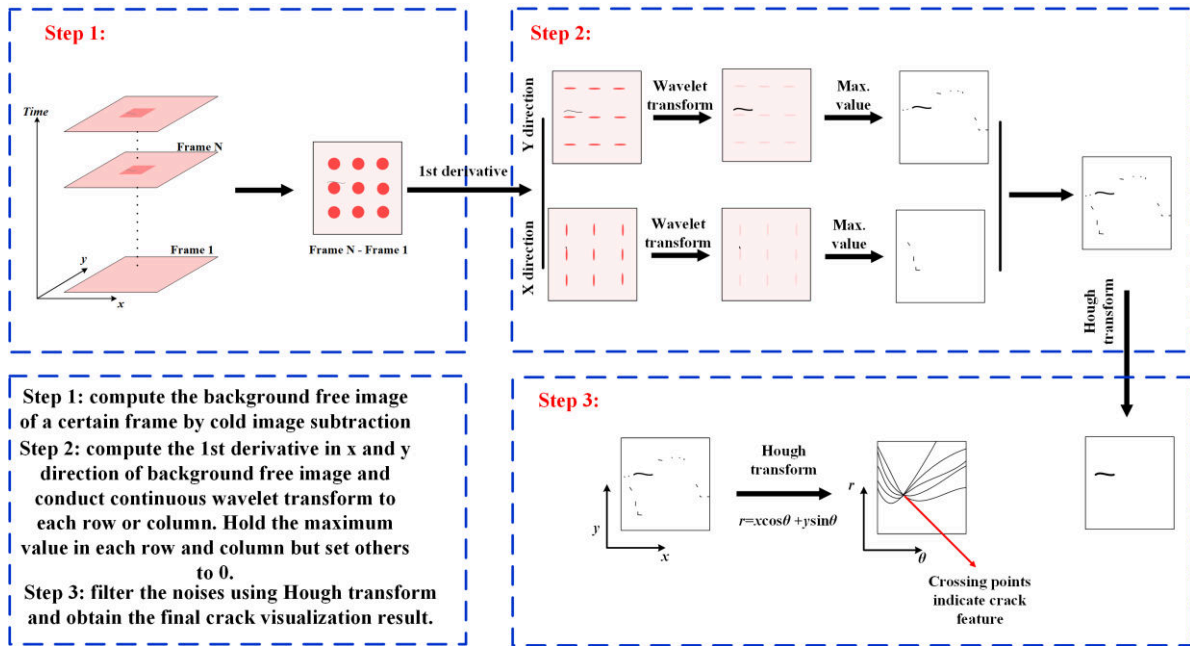
Fig. 3. Crack imaging procedure

In this section, a crack imaging algorithm combined with wavelet transform and Hough transform is developed to automatically identify and quantify a crack from the thermal images obtained by the LAST system. The derivative image is widely used in processing thermal signals to enhance edges and other important information while suppressing the noise. In LST, the thermal wave propagation along the surface will be blocked by a crack and cause local irregularity of images. In a similar manner, the presence of spatial discontinuities in thermal image caused by the presence of crack can be detected by the wavelet transform [8]. After that the peak values are extracted to isolate crack information from the thermal images. The Hough transform is a powerful tool in image processing field for the detection of features such as lines and circles [9]. So it can be adopted to automatically distinguish crack features and noises after the peak value filtering. Finally, the crack visualization result can be obtained. The algorithm is composed of three steps and the details of each step are outlined in Fig. 3.

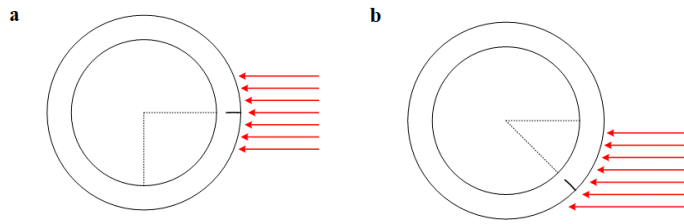
Fig. 4 laser excitation modes: (a) vertical mode, the crack direction is parallel to the laser direction. (b) angular mode, the angle of the crack direction towards the laser direction is a certain angle.

region directly. Although the application of guiding fiber or reflection lens can solve the reachability problem to a certain extent, the vertical incidence of laser is not always achievable. Thus it's also significant to investigate the influence of inspection angle to the capability of crack imaging from the point of view of practical inspection. Therefore, two kinds of laser excitation modes are considered in this work: vertical mode and angular mode (see in Fig. 4), which respectively represents the laser is heated near the crack region vertically and with a certain angle. In this work, inspection experiments under the heating angle of 30° , 45° and 60° are conducted. In experiments, the laser array is respectively generated onto the regions near the crack in the way shown in Fig. 4 to detect these defects. The laser induced on the specimen is a 4-s square pulse with 2-s heating and 2-s cooling. The power of initial laser is 80 W which means the power of each element spot in the laser array is around 1 W.

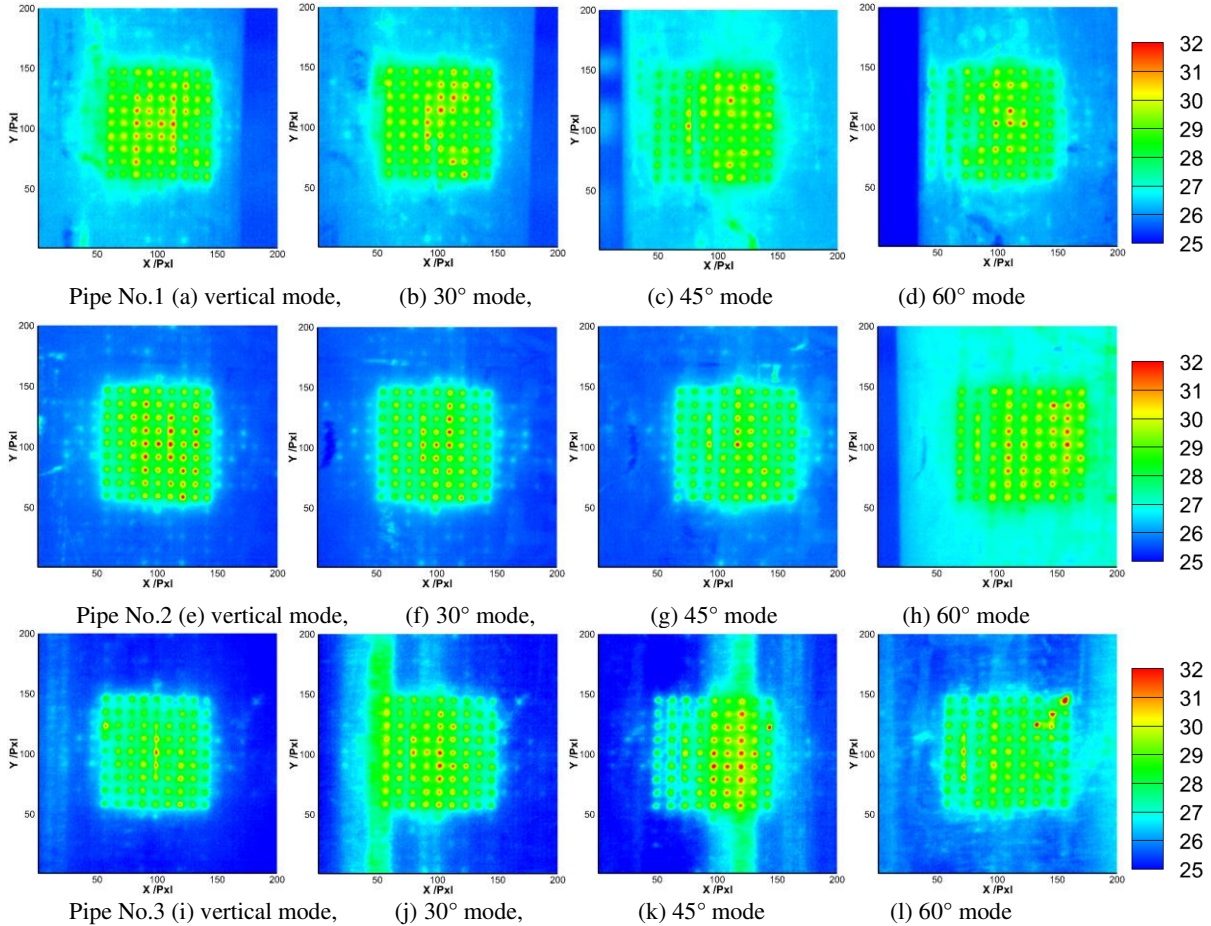
Fig. 5 Representative thermal images of pipes obtained at 2s

Fig. 5 shows the measured temperature distribution on the pipe surface after irradiated by the 9×9 laser spots array after 2 s. Although the resolution of full image is 512×640 pixels only a 200×200 pixels region near the laser source heating area is selected as the region of interest (ROI). The results show that the unsymmetrical distribution of surface temperature caused by the crack can be witnessed although the curved surface reflects parts of the laser energy and cause the uneven heating effect on the surface. With the increase of laser heating angle, the crack become less clearly in original thermal images. Then the image processing procedure discussed in section 3 is applied to the raw images. Fig. 6 illustrates the results of main steps in the image processing of ROI in Fig. 5a. Final results of all the six images are shown in Fig. 7. As we expected the laser heating patterns are greatly eliminated and all the cracks are clearly revealed. Finally, the crack length is evaluated by counting the amount of pixels that visualized the crack (1 pixel sees 0.22mm).

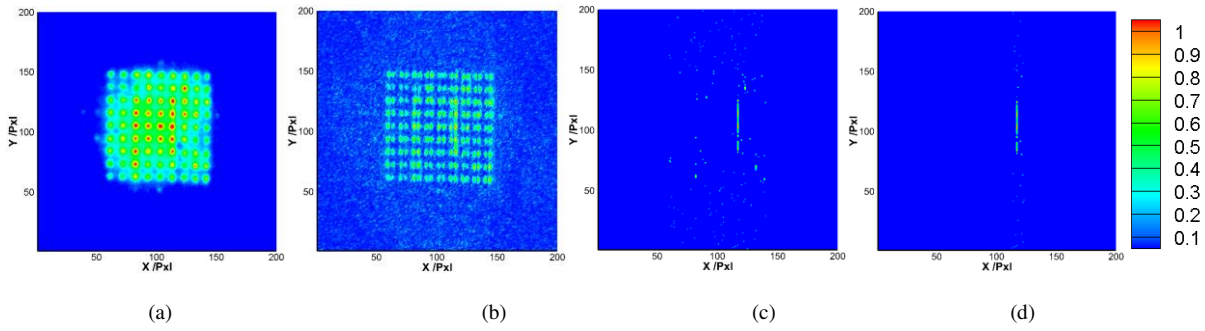
Fig. 6 Image processing procedure: (a) cold image subtraction result; (b) 1st derivative image; (c) peak value extraction result; (d) crack extraction result by Hough transform.

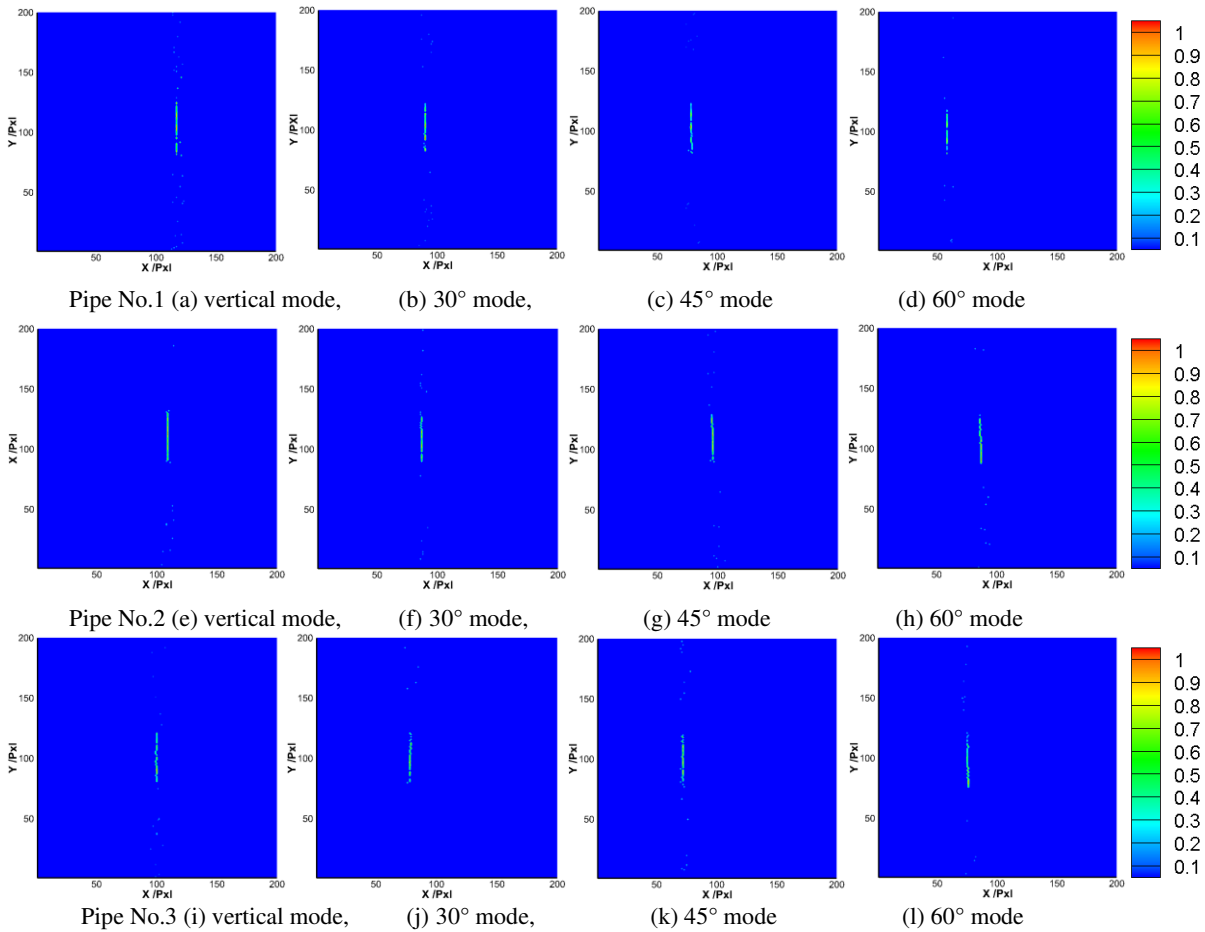
Fig. 7 Crack visualization result from measured thermal images of pipes
